Golden State Mold Inspections

ID: Partial Inspection
1117 Pacific Ave. #3
Manhattan Beach, CA 90266

Kitchen

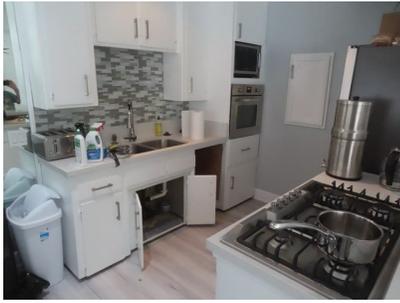
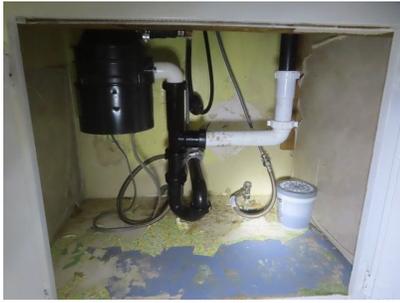
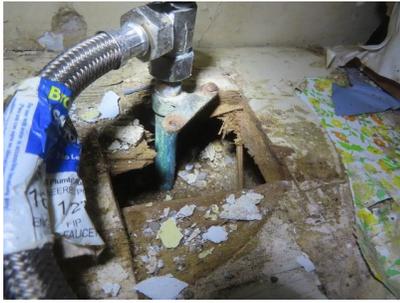
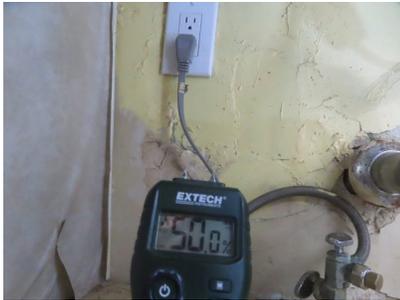
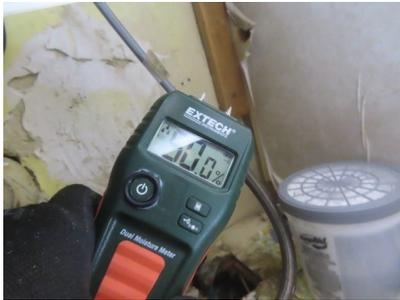
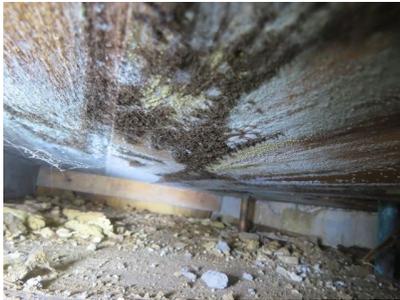
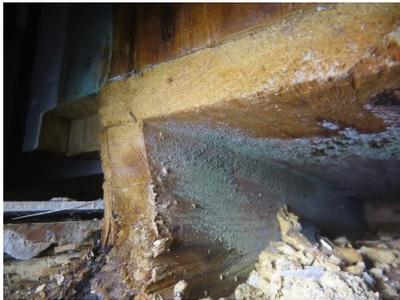
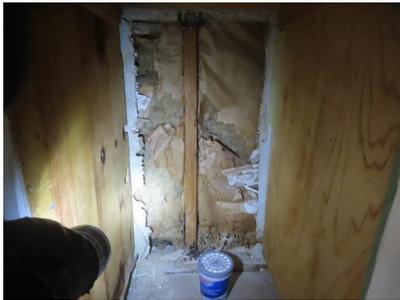
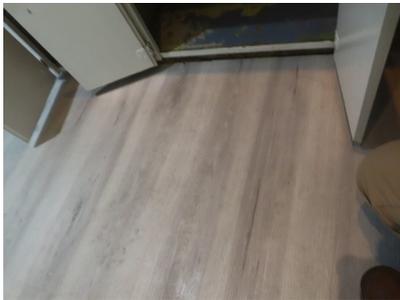
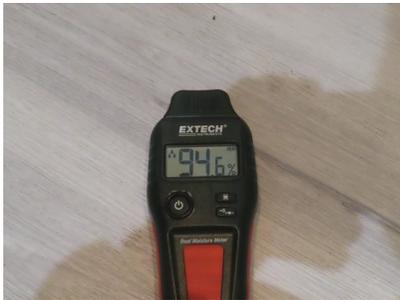
Condition: Professional Consultation

There are signs of microbial growth, water damage and high moisture test readings at the sink cabinet.

High moisture test readings extend to the adjacent dishwasher cavity and to the floor covering in front of the sink cabinet.

A mold swab sample was taken, see section on Microbial Samples.

1. Isolate the area and create a negative air environment.
2. Remove cabinetry, wall covering and floor covering to a minimum of 14" beyond any mold growth, water damage and high moisture test readings.
3. Remove any water damaged building materials.
4. Clean surfaces per U.S. EPA guidelines, which are available at www.epa.gov/iaq/molds. It is recommended this cleaning be done with an approved microbial inhibitor in all areas mold like substances are present, such as 10%-25% bleach to water solution or other approved biocide.
5. Allow the area to dry out thoroughly. Use of high powered fans and dehumidifiers may be necessary.
6. Sand wood surfaces as necessary.
7. Run HEPA filter air scrubbers for 48 hours.
8. Obtain mold clearance before removing the containment and replacing materials.
9. Ensure the source of water intrusion is properly repaired.

Note: Further inspection may be necessary once materials are removed.
